Keeping The Door Open – 6 Cyl Healey

Austin Healey Q&A

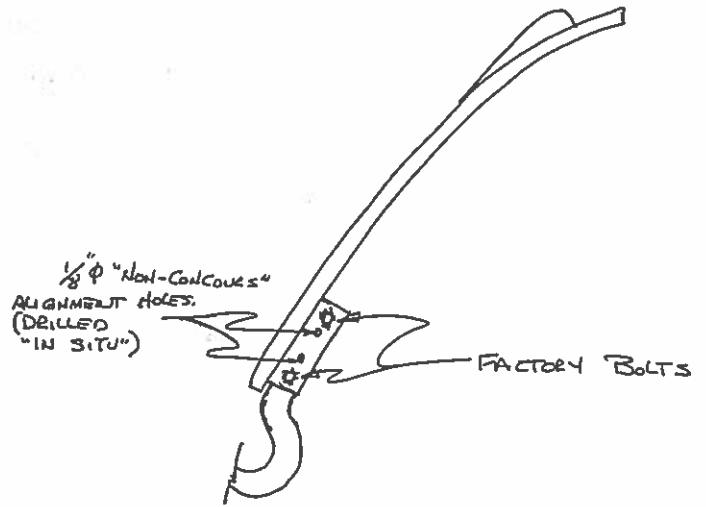
Donald provided generous adjustment (slotted holes) for each of the bolts (two on each side), which attach the hood to the hood hinges. So generous, in fact, that front-to-rear adjustment is one-half inch or more, and left-to-right (at front of hood) is more than a full inch. Adjust-and-try will get you there eventually, but in the process may very well result in damaged paint where the rear of the hood clears (or doesn't clear!) the shroud and/or where the front of the hood seats in the groove around the shroud. Been there, done that, and paid the bill for repainting scuffed areas. Since the hood was properly aligned at this time, the challenge became how to reinstall it after repair/repaint without going through the adjust-and-try process all over again. So here is "what worked for me." While the hood was still on the car, I drilled $\frac{1}{8}$ " diameter holes, two on each side,

through the hood flange and hinge. (See sketch.) Then the hood was removed for repair/repaint.

When reinstalling the hood, (with plenty of help and my best motel towels to protect the shroud), I installed, but did not tighten, the four attaching bolts. Final alignment was accomplished by inserting the shank end of four $\frac{1}{8}$ " diameter drill bits through the previously drilled holes, then tightening the four attaching bolts. Voila! Perfect alignment and no scuffed paint! ©

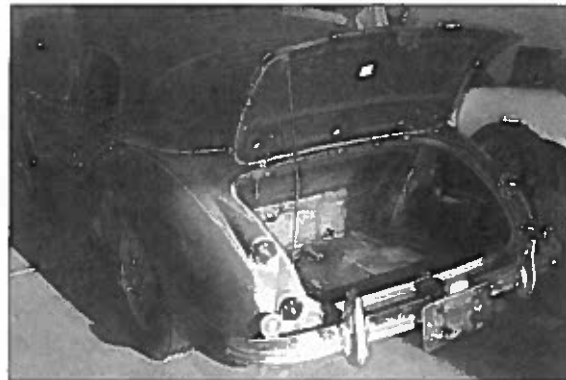
Top: What evils hide beneath the boot lid of this old Healey? Bottom, left: Boot bottom corrodes under tank and even worse in corners. Bottom, right: Inner fender panel shows surface corrosion at rear.

most evident in the rocker panels and dog legs. But experience dictated there would be other nasties lurking under the low-slung beast and, sure enough, as I began putting the car in running order, it became obvious that the driver's floor beneath the pedals was badly rotted. A new driver's side floor and repair of the front outrigger solved that problem. There was also a small hole in the boot floor beneath the battery. Removing the Armacord trunk lining and the fuel tank revealed more damage to the boot floor, and subsequent sandblasting showed that the areas between the bumper supports and the inner fender panels had the integrity of Swiss cheese. A new boot bottom was in order!

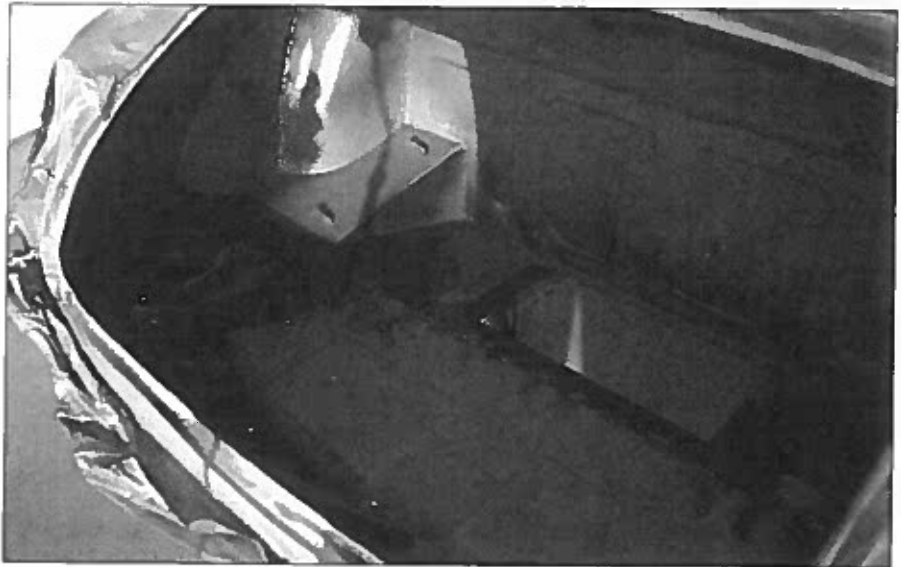
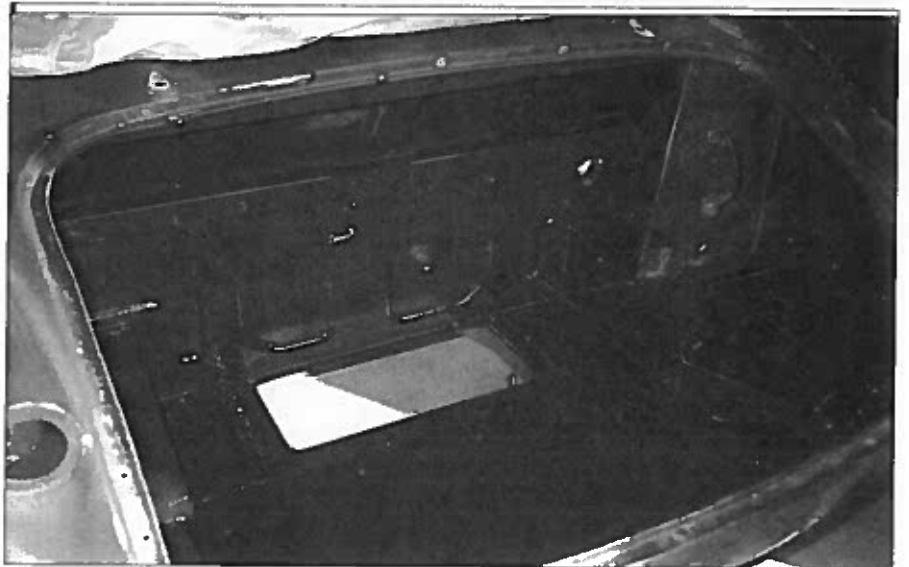
Top: New floor welded in place. Bottom: Boot area with new floor and paint.

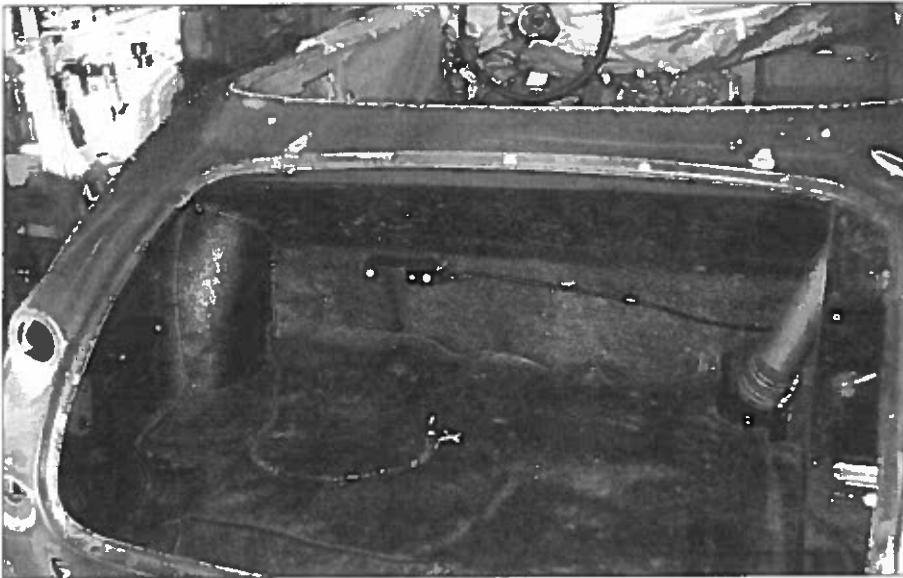
Original Armacord was cleaned and refitted after dropping in renewed fuel tank.

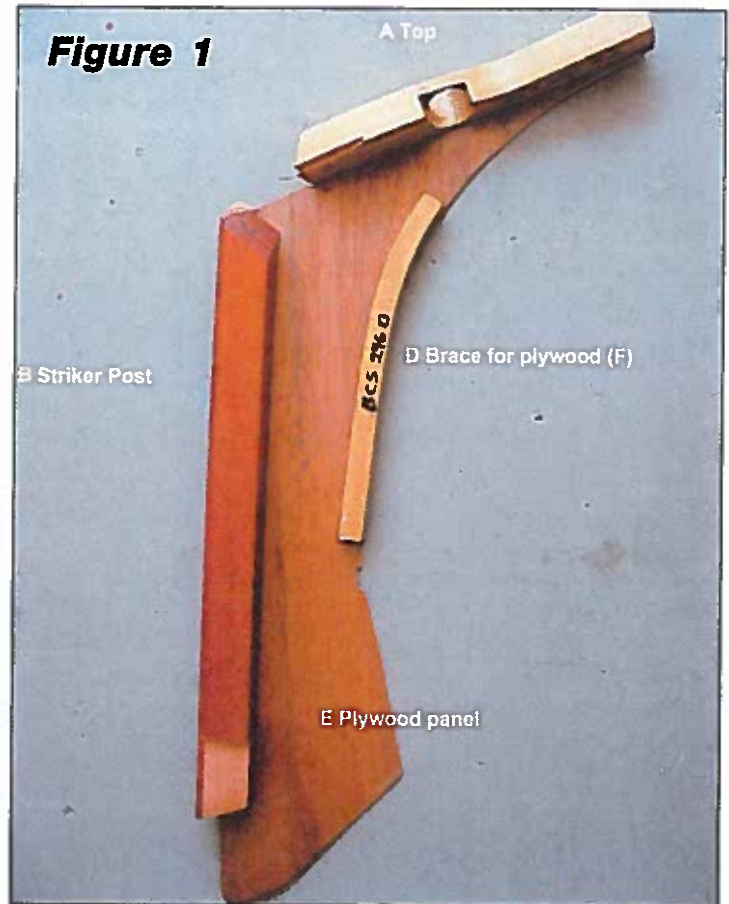
Looking at Figure 1. You'll find Plywood Panel E with Top Piece A, Striker Post B and Brace for plywood D nailed and glued in place. It's not uncommon to have to make minor adjustments to some of the pieces. If you look closely at Striker Post B, you'll notice I shaved a little off the bottom to fit around the plate on the sill that supports the door surround. Also, I had to cut a little off panel E to conform to the floor pan. Actually, I found the parts fit pretty well. Of course, once these parts are covered and mounted in the car none of these parts are visible.

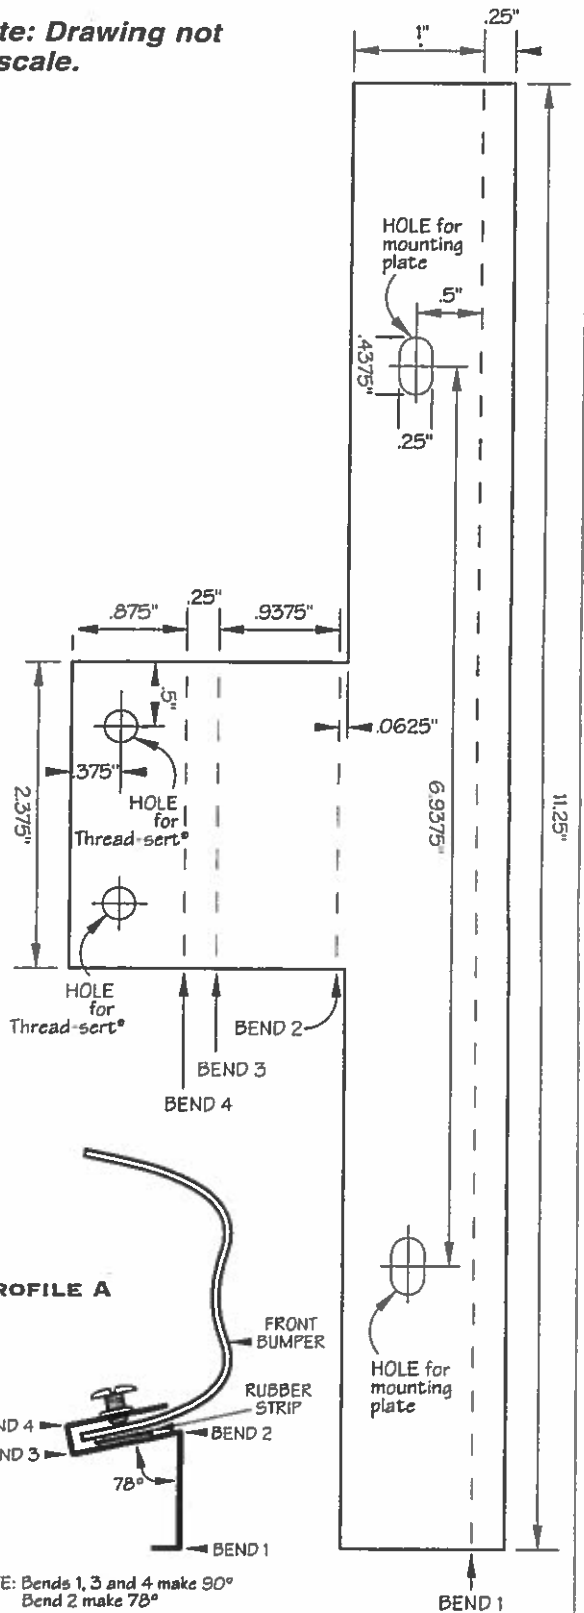
Front License Plate Bracket Plan

1. Cut a "T" shape out of 18 gauge steel following the diagram (a small sheet can be purchased from Eastwood by mail order)

2. After drilling the holes as indicated, file or sand any burrs that might exist.

3. Attach two "Thread-ert"® fasteners (size 6-32) at the area shown. (These are fantastic, blind rivets with built-in threads, allowing bolts to be fastened into metal too thin for threading.)

4. Bend where indicated using a bending tool matching to profile A.

5. Spray paint with primer and gloss black enamel. Using two stainless machine screws (1/4"-32) as shown, mount bracket to bumper. Note: also adding a strip of thick rubber will give extra grip after mounted.

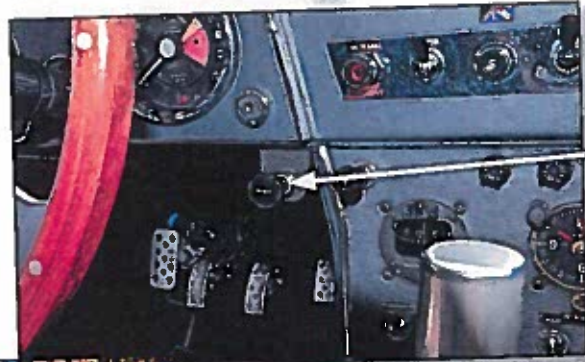
One of many mods to Gary's Healey, this PUSH knob opens and closes the scuttle vent.

Many of the factory racecars were fitted with scuttle vents to provide additional ventilation air to the interior in an attempt to reduce cockpit temperatures. The original vent consisted of a scoop in front of the windscreen and a shallow pan under the scuttle with two openings to let air into the cockpit, and a tube in the bottom of the pan to drain off any rainwater. In modifying my Healey we duplicated this concept except that we made the pan deeper and added a damper to shut off the air in cold or rainy weather. The damper is opened and closed by a "PUSH" knob located to the left of the center console and below the instrument panel. **HM**

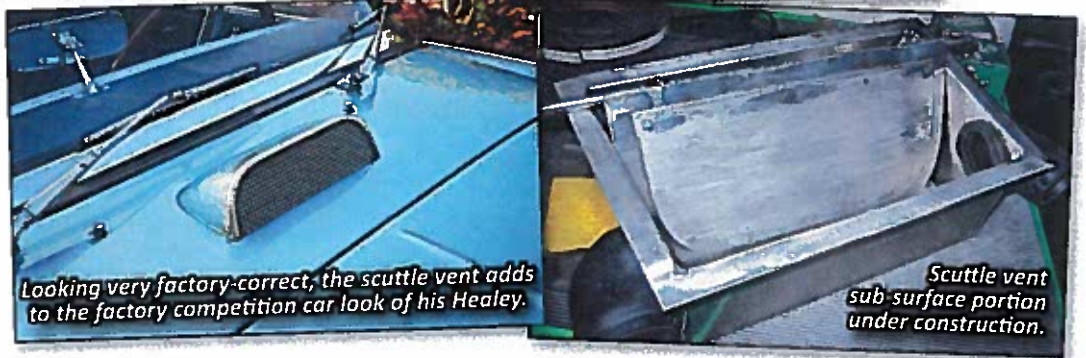
Looking very factory-correct, the scuttle vent adds to the factory competition car look of his Healey.

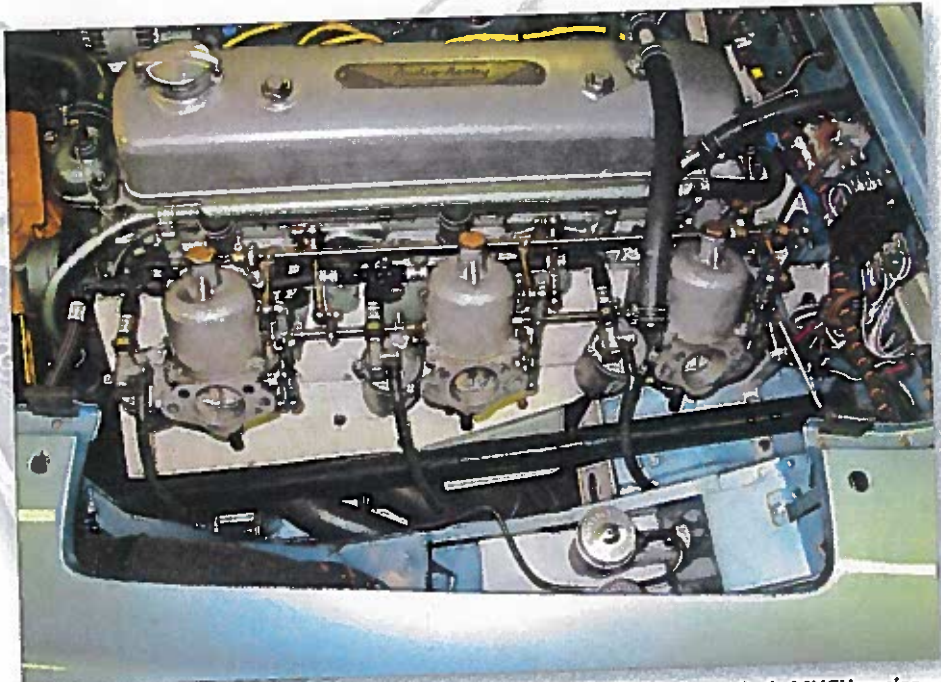
With the access panel removed, getting hands and tools near the carbs is MUCH easier, such as for removing the air filters.

This is the one I made for my Healey. It's held in place by two quarter-turn Dzus fasteners. **HM**

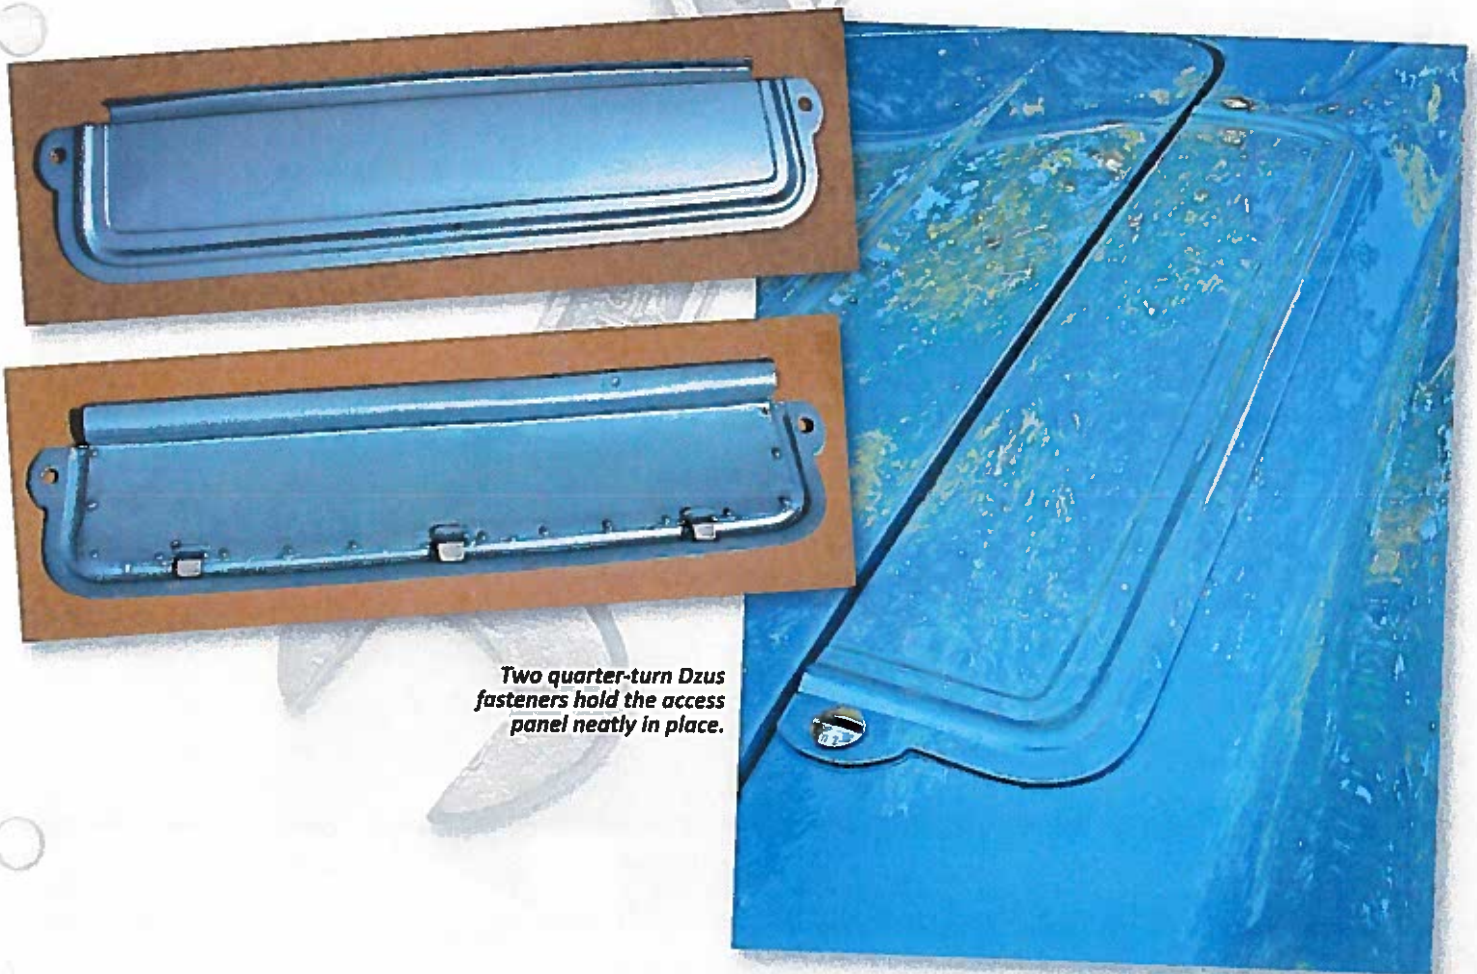
Two quarter-turn Dzus fasteners hold the access panel neatly in place.
