Healey Hardtop Repair

by Roger Moment
Rocky Mountain AHC

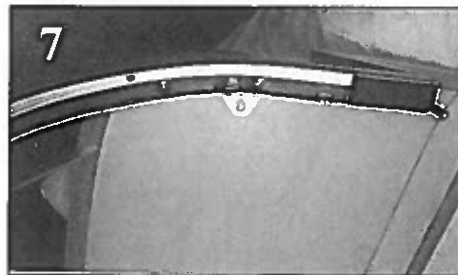
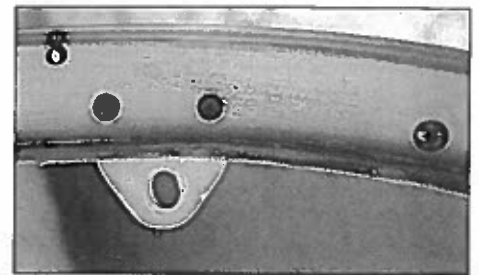
Photo 7: A plain rubber strip covers the screws on the bottom side of the rear rail. A sponge seal strip is glued on top and butts to the thick pad at each corner. **Photo 8:** The hold-down tab bracket attaches to the rear rail with two pan-head screws. The single screw to the side is one of 9 that attach the aluminum lip piece, to which the rear window rubber strip fits, to this rail.

The Al lip to which the lower backlight rubber attaches (see Figure 11) is held to the rear rail with a number (9 or so) of small screws.

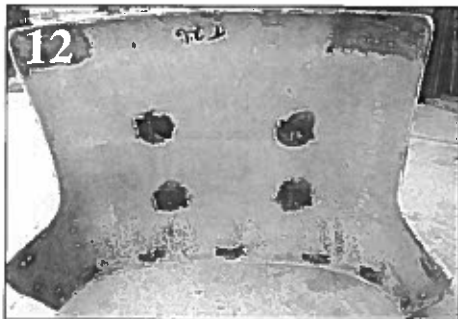
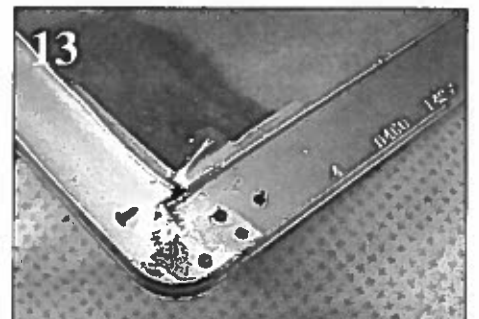
Photo 12: The fiberglass shell is fragile too. Note the carpet and rubber block pads that are glued to the under side. These do not need to be removed. **Photo 13:** The serial number and date of manufacture is stamped to the underside of the right cant rail (side window opening).

shell do not have to be removed, but should be checked to make sure they don't fall free and get lost. On the bottom side of the right side door opening trim piece will be found some stamped numbers, giving the hardtop date of manufacture and its serial number (see Figure 13). And finally, stripped of its trim, the fiberglass shell is fairly fragile and vulnerable to damage. Look it over carefully for cracks, especially along the flanges where the Al pieces attach.

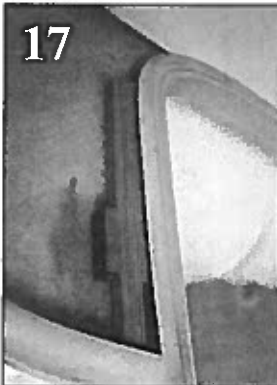
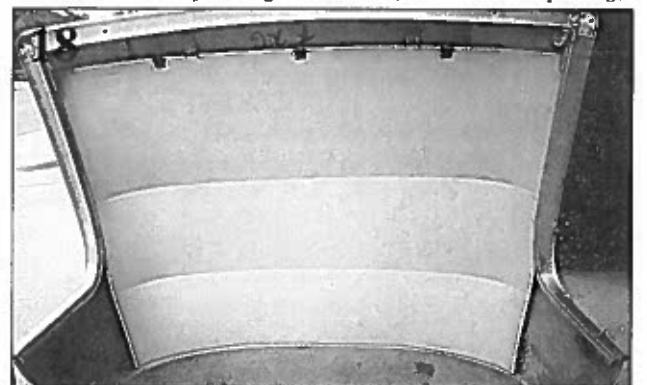
Photo 17: The wood blocks are mirror images of each other. They are attached by the top two screws in the side rails. **Photo 18:** The headliner slides in from the rear. Remember to handle it VERY carefully, as it is fragile and the exact material is not available from any source.

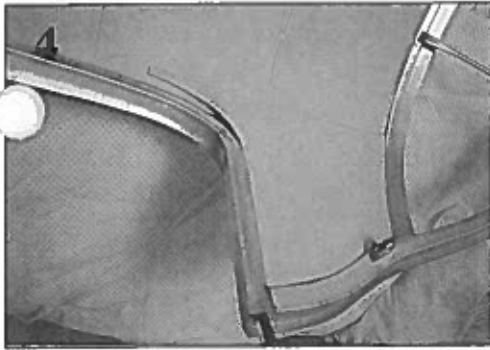
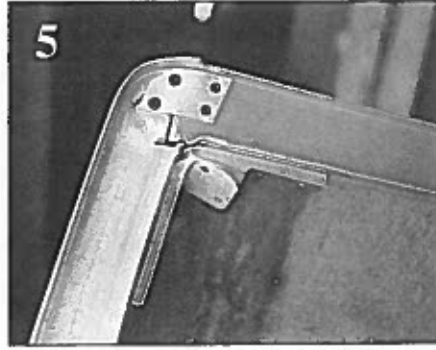
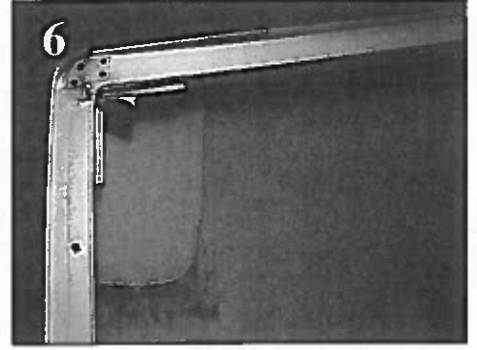
Photo 4: Slide the rear quarter panels upward to release. Once they are pushed up about 1 inch, they will clear the door opening trim and be easier to work free. **Photo 5:** Remove the two corner plates that join the front and side aluminum pieces. They are attached by very small sheet metal screws. **Photo 6:** This view shows one of the front corner pieces of trim material that is glued to the shell above the hold down clamp.

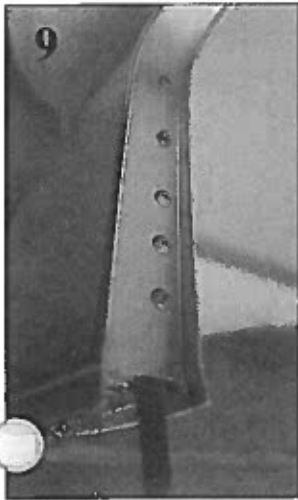
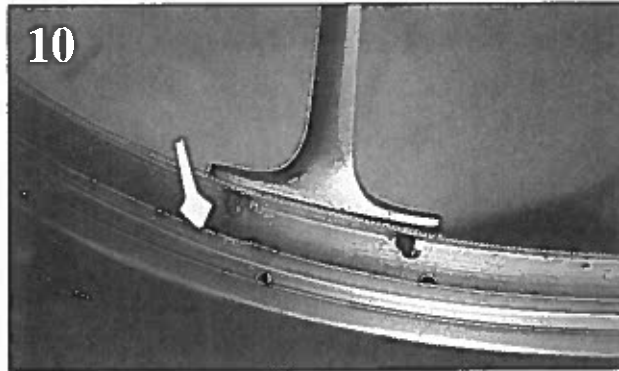
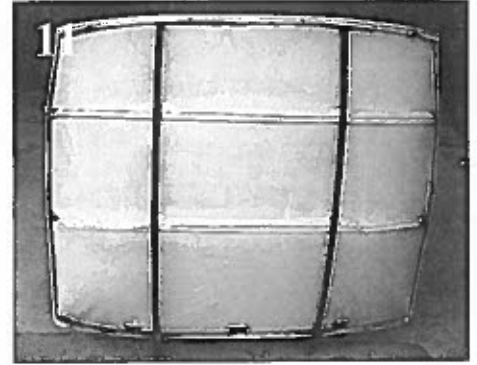
Photo 9: The top two screws attach the wood blocks; the bottom three are for the steel angle bracket. **Photo 10:** The bottom of each rear bracing bar is mounted with countersunk screws and acorn nuts. The inner face of the rear rail is covered with headliner material. The separate flange to which the rear window rubber seats is marked by the arrow. It has not yet been screwed to the rear rail. **Photo 11:** The headliner mounts to a steel subframe. Vinyl dyes can restore stained material to the original off-white/light gray color.

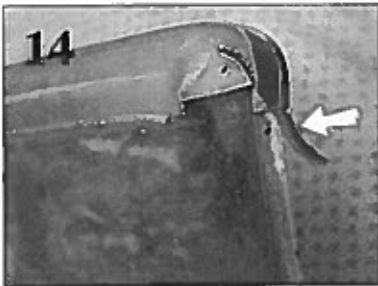
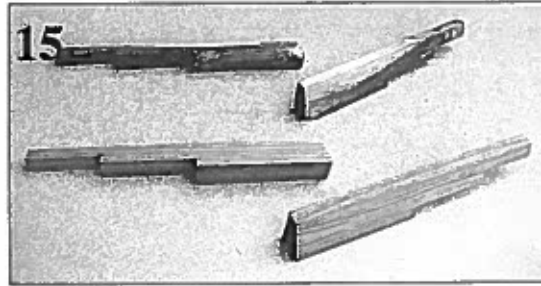
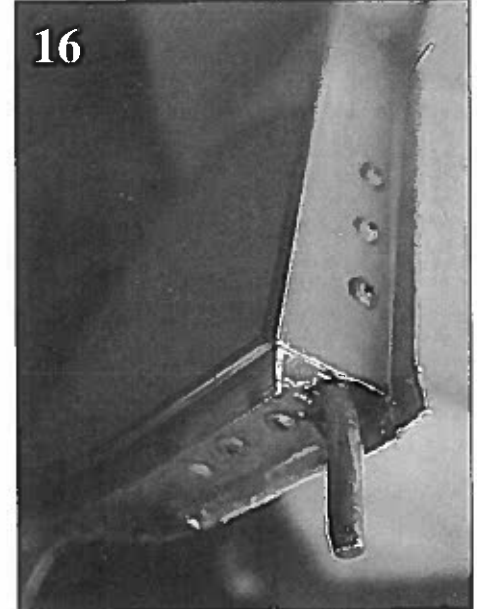
Photo 14: Slide the aluminum trim pieces onto the shell using a $\frac{1}{4}$ " wide by $\frac{1}{8}$ " thick clay sealing strip. **Photo 15:** Make new wood pieces if your old ones are rotted or warped. The shape is rather complex, being both beveled and tapered. **Photo 16:** Insert the steel angle brackets when fitting the lower rear rail, and tighten using six screws on each.

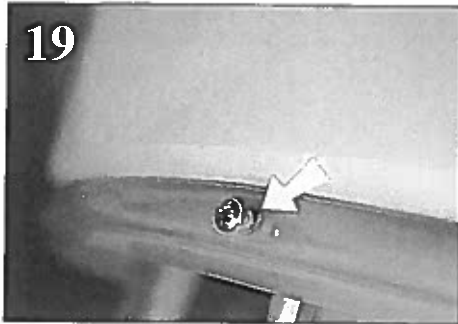
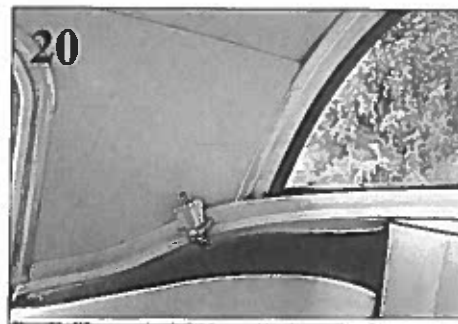
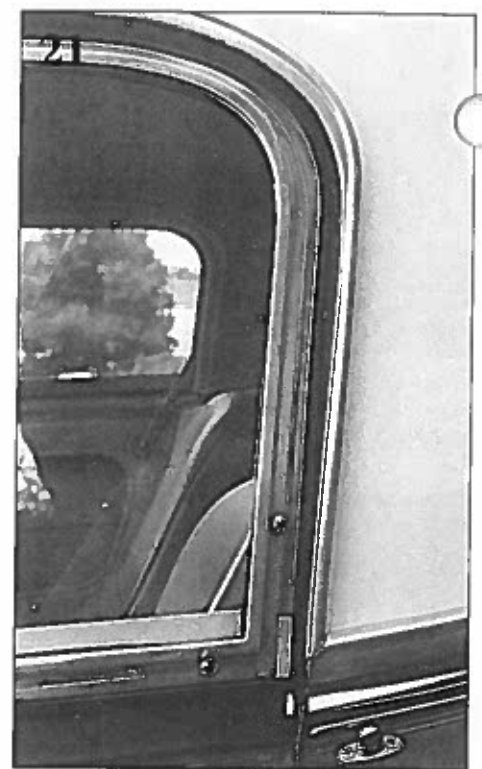
Photo 19: Wrap a small ring of clay around the screw that attaches the top of the rear window braces. This seals out water. **Photo 20:** When mounting the hardtop, position the hold-down J hooks so that they do not touch the cockpit surround aluminum. Careful positioning of the hood will allow the wing nut to just clear the trim material when tightened. **Photo 21:** Correct fit shows a uniform gap between the side curtain and cant rail. Still, the hardtop rides somewhat high at the corner against the cockpit surround. This space is filled by the thick rubber block at these corners.

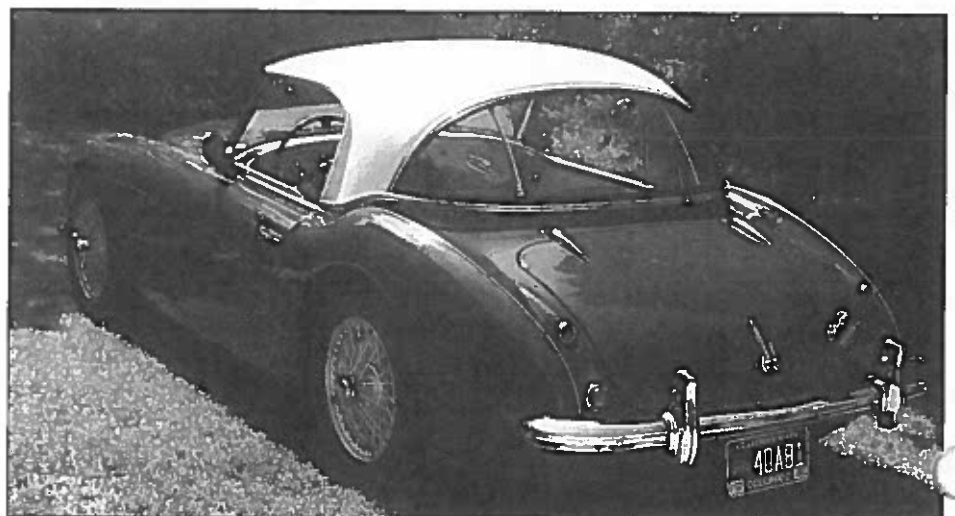
Photo 22: The hardtop looks good and provides quiet protection from sun and wind on tours. The rear window (backlight) has "PERSPEX" heat stamped into the left corner, parallel with the bottom edge (about 3" back from the front edge and 1 1/4" up from the bottom one).
